Operator: Calvary Coal Co. Inc.

Mine: Mine No. 4

Date: June 9, 2003

Classification: Machinery

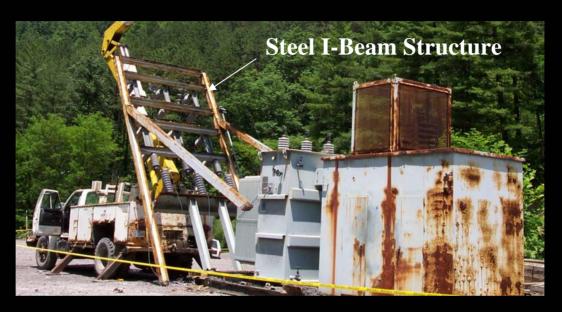
- The A 49-year old mine manager (victim) with 29 years mining experience and three other miners were dismantling Pemco electrical substation.
- The victim was operating a Simon-Telelect 42-foot aerial bucket truck, from within the elevated bucket, which was attached to the steel I-Beam structure of the substation by a winch (JIB Crane) and nylon rope assembly.
- When the mine manager used the winch (JIB Crane) to lift the steel structure, the nylon rope broke causing the aerial bucket to move upward suddenly throwing the mine manager out of the bucket.
- The mine manager, who was not wearing a safety belt or harness, fell 29 feet to the ground causing fatal injuries.

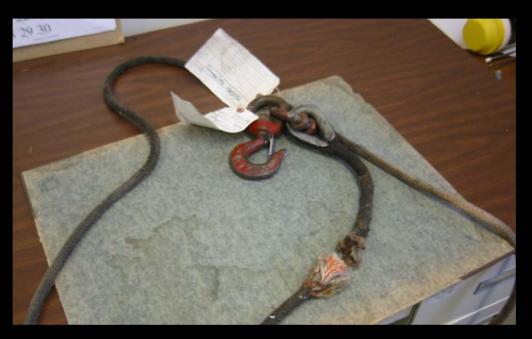
- The substation had been moved to the parking area on Saturday for dismantling and transport.
- Miners had gone to the parking area to remove the steel structure from the Pemco electrical substation.
- The structure consisted of several 6-inch steel I-Beams,
  1 steel plate, and 20 large insulators and measured 21' 10 ½" tall by 9'-6" wide.

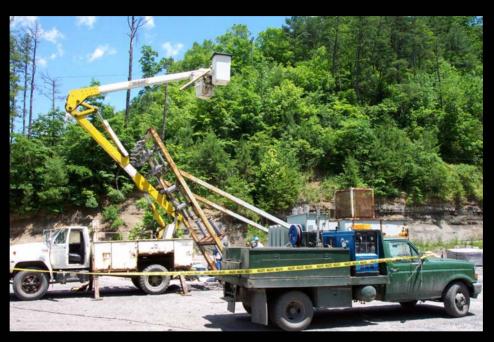
- The mine manager elevated the bucket and placed a nylon winch rope around the top beam of the steel structure, placing its hook back around the rope.
- The structure was freed from the substation.
- The mine manager used the winch (JIB Crane) to lift upward on the steel structure, which bent the I-Beam.

- The nylon rope failed at the point where it contacted the edge of the steel beam, causing the aerial bucket to move upward suddenly throwing the victim backwards out of the bucket.
- As he fell to the ground, the victim struck the steel structure several times and the bumper of the aerial bucket truck.

- <u>Causal Factor</u>: A suitable hitch or sling was not used to lift the steel I-Beam structure.
- *Corrective Action:* Mine Management should issue policy that ensures the use of a suitable hitch or sling when lifting heavy loads.

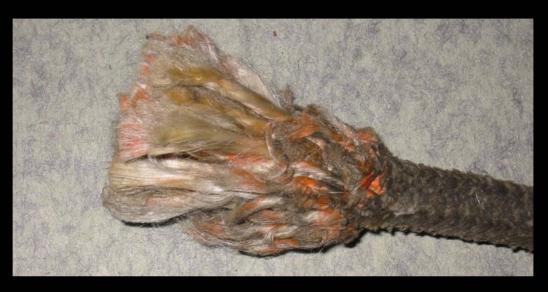
- The bucket truck consisted of a 1991 Model T-4042 Simon-Telelect aerial device with a Model F800 Ford truck chassis.
- The aerial device was designed to be used around energized electric lines.
- The boom on the aerial device had a reach of 42'.
- The maximum lifting capacity of the jib crane was 2,000 pounds. Its safe lifting capacity decreases when the boom is at a more horizontal angle.
- The upper boom arm position was estimated to be less than 30 degrees above horizontal. In this position its maximum safe load was approximately 700 pounds.
- The weight of the steel structure being lifted at the time of the accident was approximately 4,000 pounds.

- <u>Causal Factor</u>: The aerial bucket was used to lift a load which exceeded its rated capacity.
- <u>Corrective Action:</u> Mine Management should issue policy that equipment be used only in accordance with manufacturer's suggested recommendations.

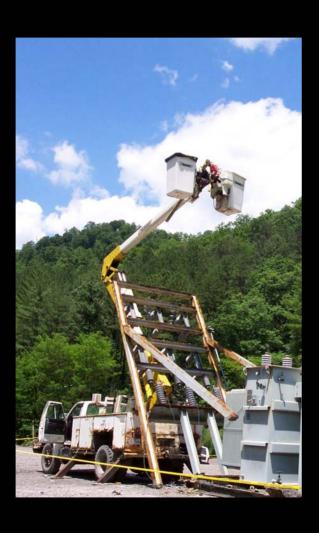
- The rope that failed during the accident was estimated to have a breaking strength of 10,500 pounds and a working strength of 2,100 pounds
- Using the rope as a choker hitch reduces the recommended working capacity of the sling by 20 %. The rope was run through the hook close to the top of the beam, reducing its working capacity by another 20% (ANSI Standard B30.9)
